Using Insulating Materials for the Construction of Salt Kilns

Peter Meanley has spent four years researching this subject and reports the results of his investigation here

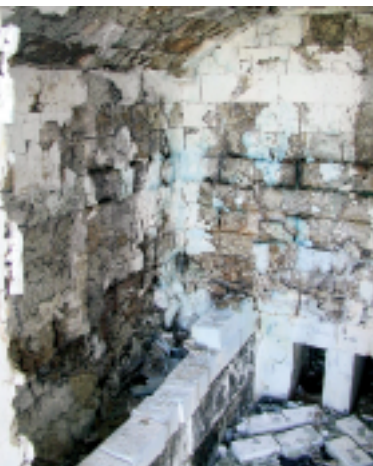
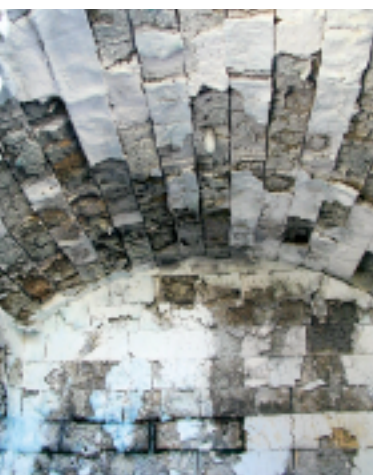
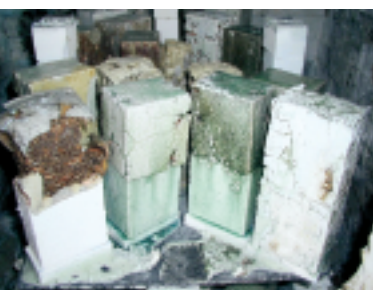
Top: and centre: Kiln #1 after salt firing 63 before dismantling. Above: Some of the new tests fired at the top level in the kiln.

Salt firings #31 to 63 were undertaken between September 2001 and February 2002. During these successive firings the roof and walls of the kiln deteriorated seriously. From salt firing #43 onwards regular attention to the roof through the application of Purimachos Refractory Glaze Wash. (PRGW – NT7), did make a significant difference in limiting further deterioration.

After salt firing # 63, all new tests had undertaken 33 firings and the time had come to make a thorough analysis preparatory to the dismantling of Kiln #1. The Saffil blanket and 23/34 grade laminate were recorded as being worthy of further testing. Of the new tests, as a general principle, those tests which featured a cement on top of a glass displayed a fragmented top coat after firing. In many instances the glass beneath was still good and protecting the base brick. What was also interesting, was that in some instances, the lower grade brick was as good as or even better than a particular higher grade brick. It was recorded for instance, that a BNZ 23HD brick was, at the end of 33 firings, in a better state than a BNZ 30 grade immediately below it in the pile of tests.

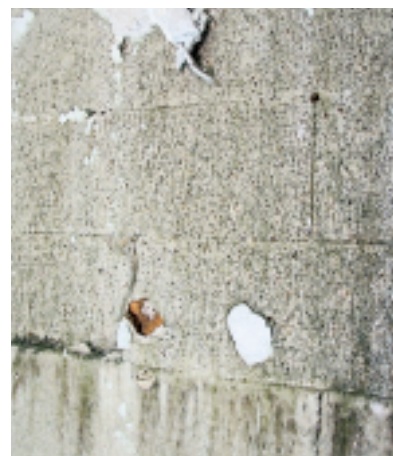
Top: Salt firing #50. Bricks HD 25 coated with NT8.
Above: Salt firing #50. Caldor 26 brick, NT8 coating.

NT8 (Pyruma 1A) is believed to be the best resist, on the 25HD and Calor 26 bricks.

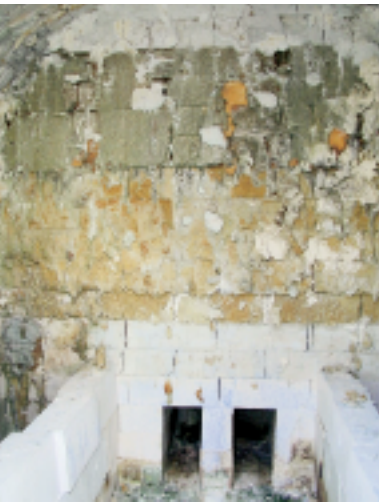
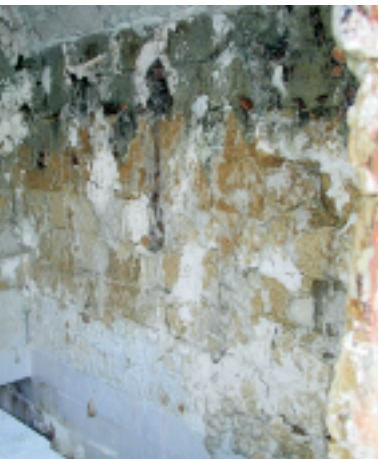
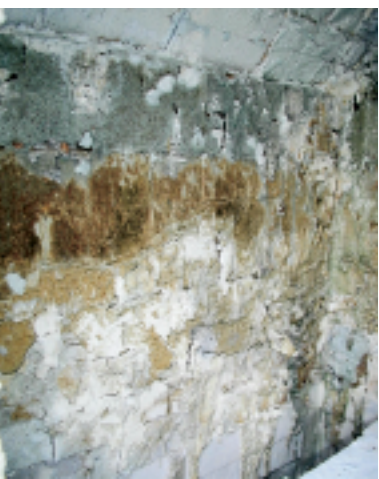
*Kiln #2 after 80 firings.
Sides and back walls.*

In October 2003, the 80th and last salt firing was undertaken. The final 21 firings had been undertaken with little to comment upon. Each firing was, and always had been preceded by a visual inspection and a light 'touch up' with NT8. A visual analysis of the kiln and a photographic session after the final firing revealed: The difference in deterioration between the 25HD and Calor 26 bricks was slight; The differences between these two types of brick treated with NT7 and NT8 was also slight. This evidence can be assessed from those tests placed in the kiln before firing #38 and which received no 'touch up' before any of the successive 43 firings. The other tests of the same bricks were in place from the outset of Kiln #2 before the 80 salt firings. The bricks which have undertaken 80 firings were a little more debased but I am confident that the life expectancy of both types is good.

By firing #59 NT8 was the standard 'touch up' material for all parts of the kiln requiring light attention. This was particularly so for the entire arch where the peeling back of the original NT9 was exposing parts of the roof to the possibility of attack. Prior to each firing, a five minute remedial 'touch up' by a two-inch brush attached by tape to a two-foot long stick enables all parts of the kiln to be easily accessible. For some serious damage to some bottom course 'bubble alumina' bricks close to the burners and the areas where the side wall meet the back walls and where a significant hole has occurred, Lupufest 901 cement was applied and overpainted with NT8.

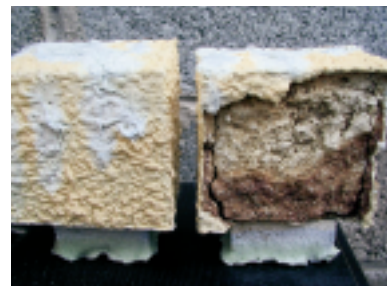
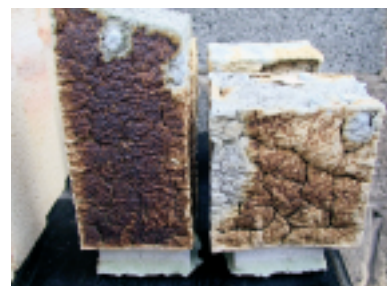
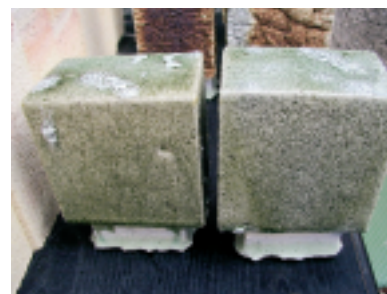
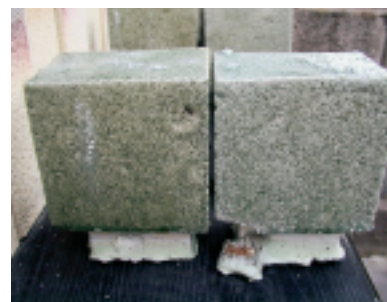
*Results of tests using
From the top: HD 25
brick and Furnacecoat.
Calor brick and ITC,
43 firings.
HD25 brick with
NTE coating.
Calor 26 brick and
NT7 coating, 43
firings.*
